Ferroscope TT

Introducing the world's most advanced ET System for quantification of magnetite exfoliation blockage in stainless steel boiler tubes (*)

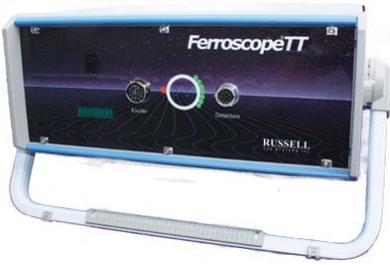
The complete ET System solution for detection and quantification of magnetite exfoliation flakes in stainless steel tubes. (*)

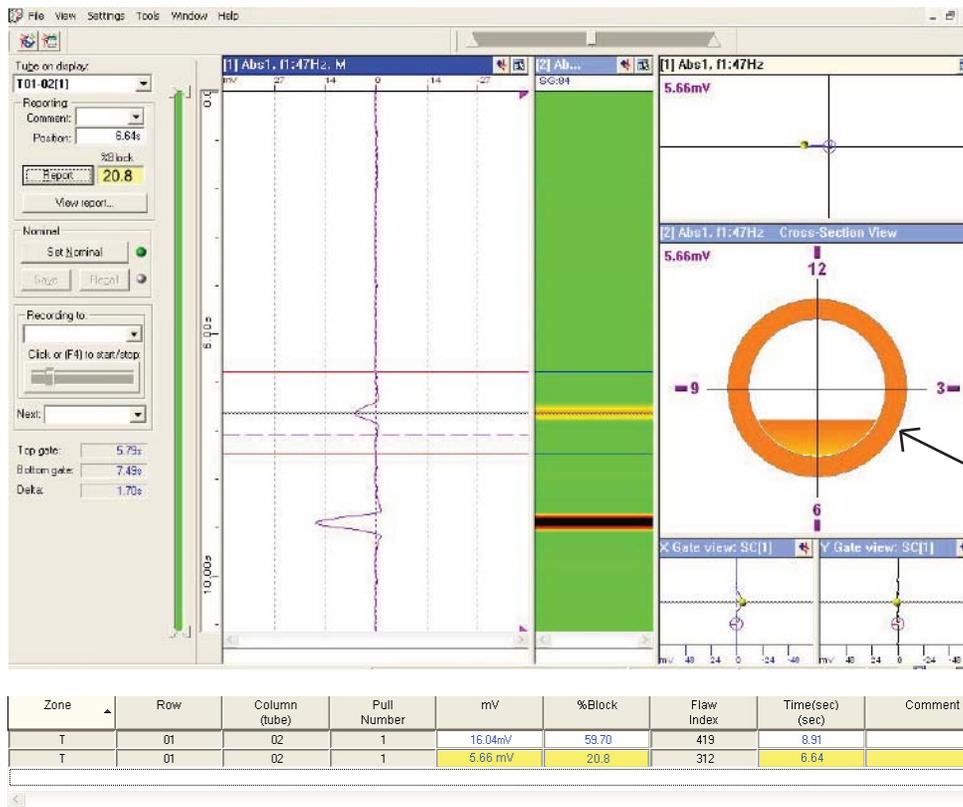
The ET system consists of the Ferroscope TT unit and a specialized scanner which, can inspect the vertical and horizontal sections of the tubes (including bends) in one run.

- Built-in report generator creates an Excel file
- Friendly Graphics User Interface
- Realtime percentage blockage calculation
- Overview mapping
- Cross-section image of blockage
